Manhole Inspection Summary

Manhole # S15Y__009MH

Insp Date: **6/30/08 12:50 PM**

Location Address: **2630 desoto rd**

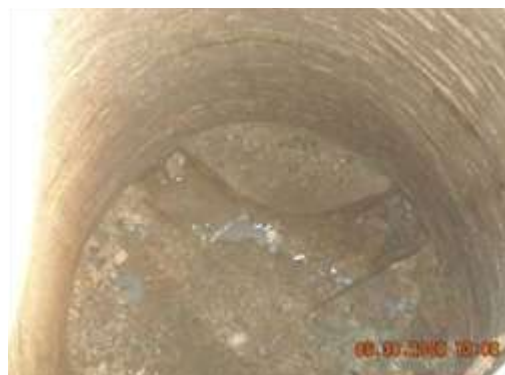
Defect 6

Condition: ☐ Sound ☐ Cracked ☐ Root Intrusion ☐ Deteriorated ☐ Leaks ☒ **Debris**

debris in channel & bench

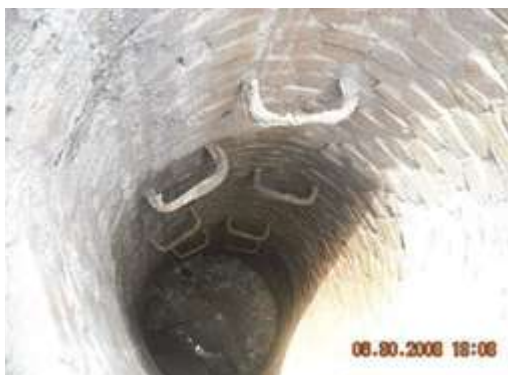
Defect 4

Steps Count: **9** Missing: **0** ☒ **Corroded**

Surcharge ☒ **Evidence Of Surcharge** Depth: **12** (ft.) ☐ Active Surcharge Present

surcharge evidence, corroded steps

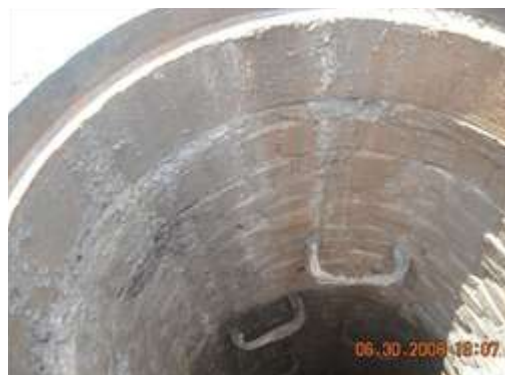
DEfect 3

Subject To Ponding: **Sheeting**

inflow evidence from sheeting

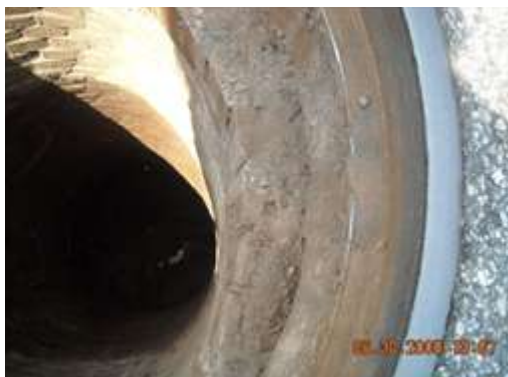
Defect 1

Frame Offset: **2** (in.)

☒ **Leaks**

frame offset
